BOLETIN TÉCNICO DE SEGURIDAD OPERACIONAL AÉREA

BT-01-2013 EUROCOPTER ECUREUIL AS350B3

ASUNTO: ROTOR DE COLA - HUB - ROTOR DE COLA (TRH) CUERNO PITCH LIMITES CONTROLES DE MANTENIMIENTO Y TIEMPO

SUBJECT: TIME LIMITS/MAINTENANCE CHECKS - TAIL ROTOR - Tail Rotor Hub (TRH) pitch horn

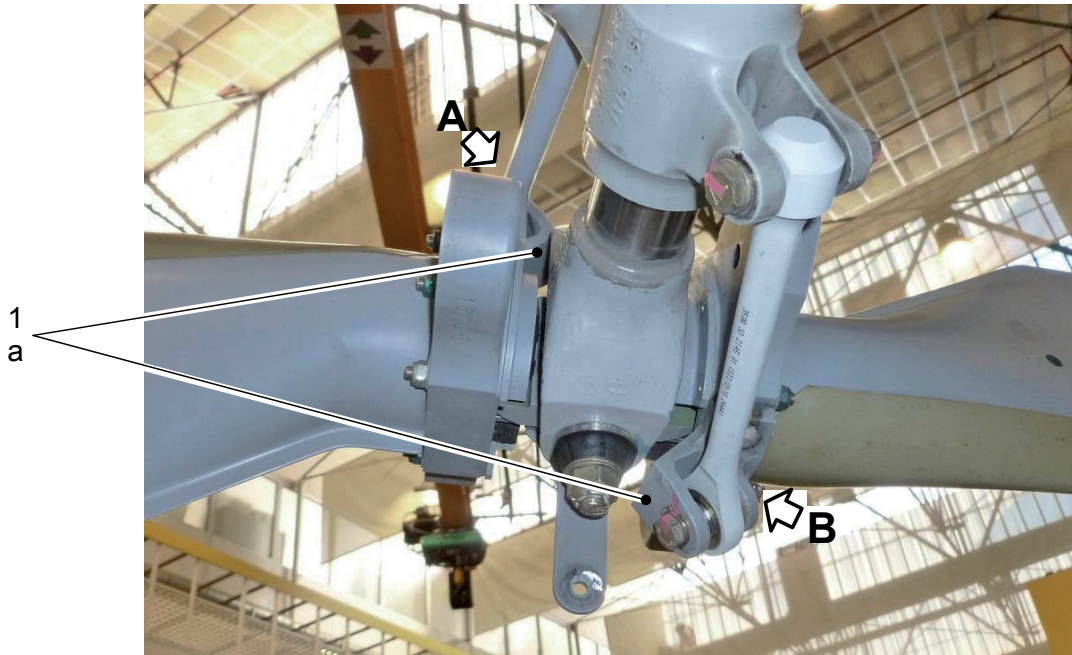
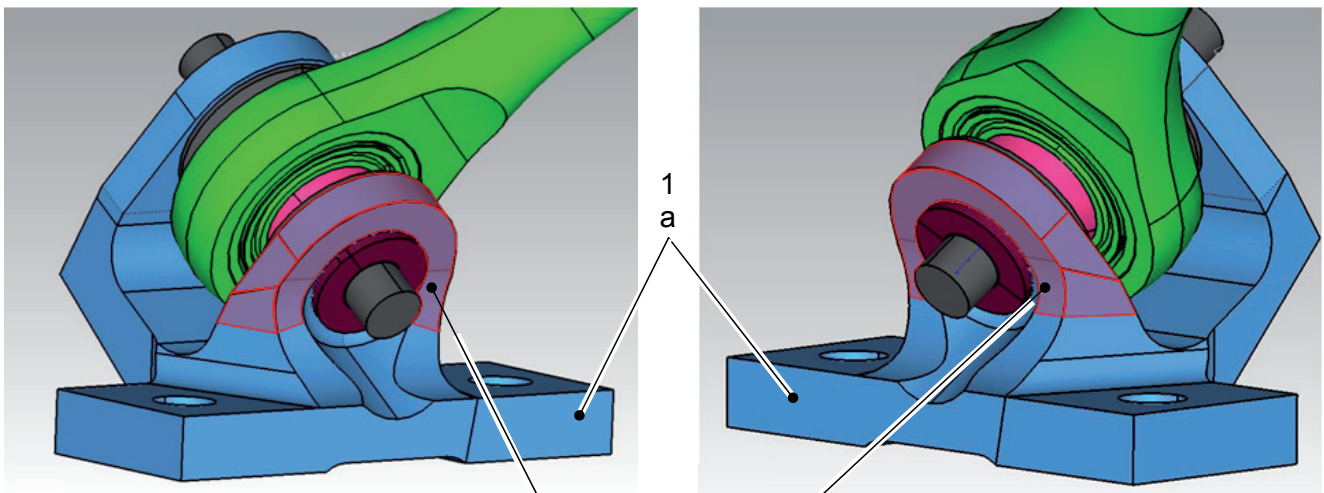
Figure 1: Areas to be checked for cracks

EUROCOPTER has been informed of a case of crack detection on the yoke of a TRH pitch horn. If this crack is not detected, it may eventually lead to the failure of the two horn yokes, resulting in the loss of the anti-torque function.

Visually check that there are no cracks on the inner yoke of the two TRH pitch horns (a) (Figure 1, DETAIL A and B). If in doubt, carry out a dye-penetrant test.

Areas to be checked

- case 1: no cracks detected on the two TRH pitch horns: leave as is and proceed with the final steps as per paragraph 3.B.3.
- case 2: at least one crack detected on the TRH pitch horn: remove and replace the incriminated horn as per paragraph 3.B.2.b. before resuming flights.

- Remove the TRH pitch horn (a) as per MRM Work Card 64.10.00.707 or AMM Task 64-10-00,8-2.
- Install the TRH pitch horn (1) as per MRM Work Card 64.10.00.707 or AMM Task 64-10-00,8-2.
