BOLETIN TÉCNICO DE SEGURIDAD OPERACIONAL AÉREA

BT-02-2013 EUROCOPTER ECUREUIL AS350B3

ASUNTO: INSPECCIÓN DE TIEMPO DE LOS LIMITES DE MANTENIMIENTO - ROTOR DE COLA (TRH) BASE DE LAS VARILLAS DE CAMBIO DE PASO

SUBJECT: TIME LIMITS/MAINTENANCE CHECKS - TAIL ROTOR - Tail Rotor Hub (TRH) pitch horn

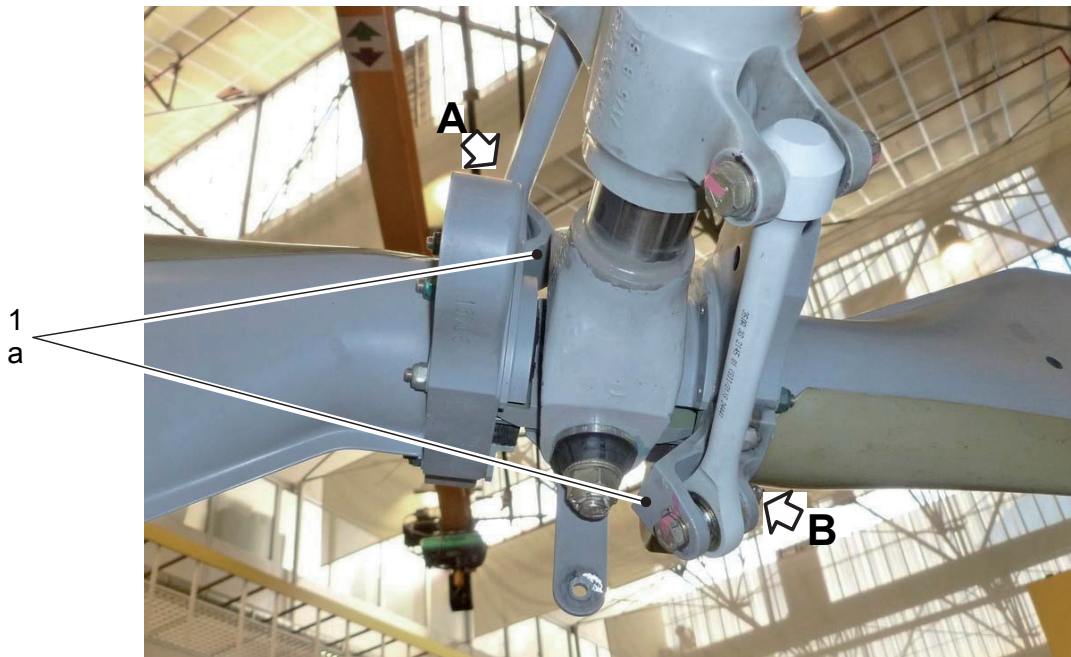
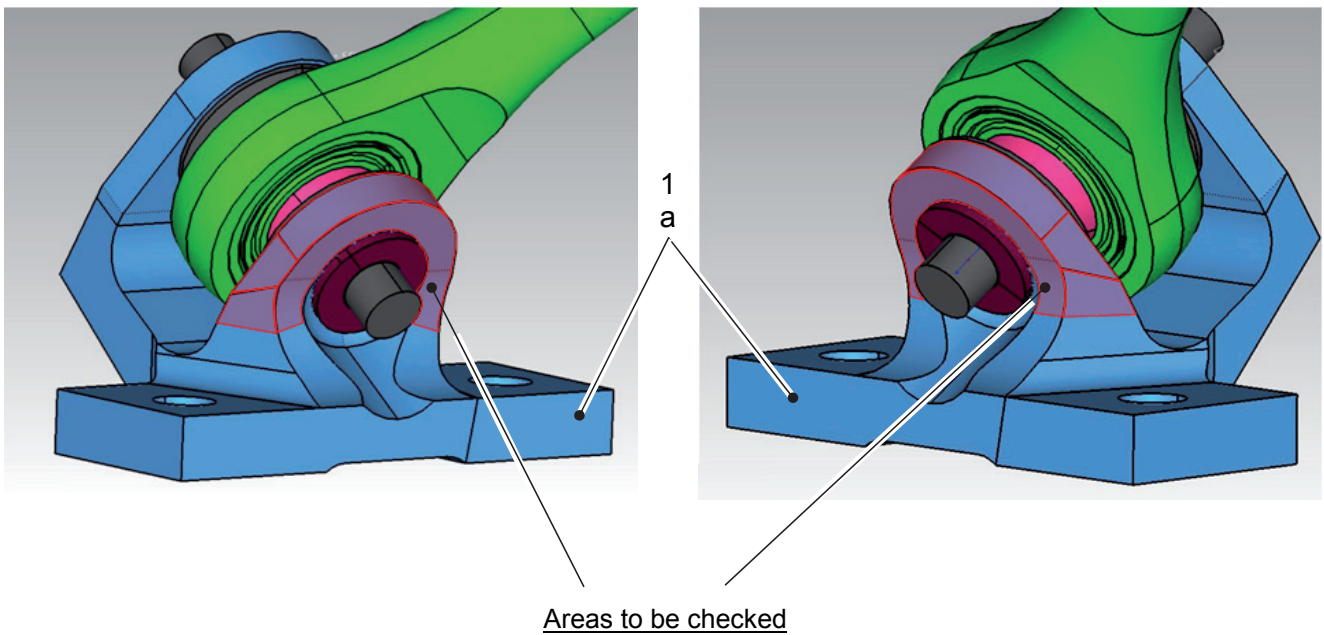
Figure 1: Areas to be checked for cracks

EUROCOPTER has been informed of a case of crack detection on the yoke of a TRH pitch horn. If this crack is not detected, it may eventually lead to the failure of the two horn yokes, resulting in the loss of the anti-torque function.

Visually check that there are no cracks on the inner yoke of the two TRH pitch horns (a) (Figure 1, DETAIL A and B). If in doubt, carry out a dye-penetrant test.

- case 1: no cracks detected on the two TRH pitch horns: leave as is and proceed with the final steps as per paragraph 3.B.3.
- case 2: at least one crack detected on the TRH pitch horn: remove and replace the incriminated horn as per paragraph 3.B.2.b. before resuming flights.

- Remove the TRH pitch horn (a) as per MRM Work Card 64.10.00.707 or AMM Task 64-10-00,8-2.
- Install the TRH pitch horn (1) as per MRM Work Card 64.10.00.707 or AMM Task 64-10-00,8-2.
