DIRECCION GENERAL DE AERONAUTICA CIVIL

INTRODUCCION

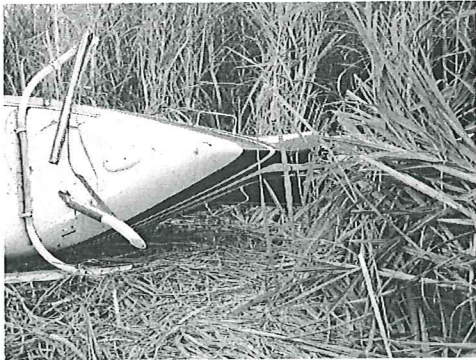
Fotografía No. 3

Vista del área trasera del helicóptero

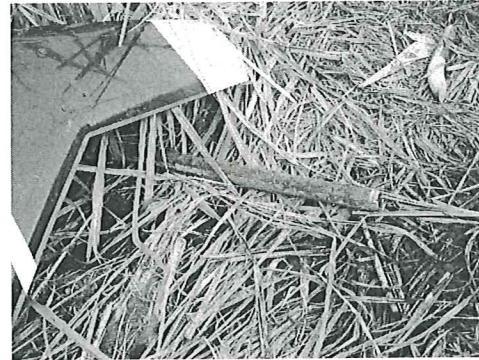
Fotografía No. 4

vista de los restos del estabilizador

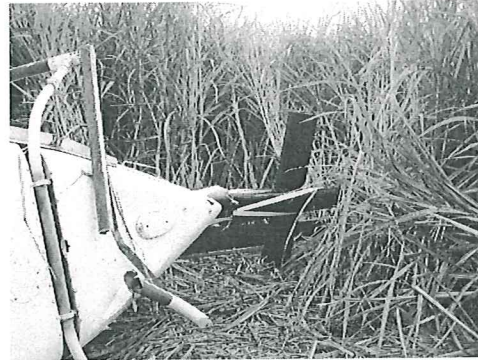
El helicóptero se encontró recostado sobre su lado derecho, el botalón de cola se encontró fracturado aproximadamente 13 pulgadas de su base, el rotor principal y el rotor de cola con daño completo en las palas, la base de la transmisión se encontró con daños severos al igual que la cabina.

Fotografía No. 6
vista del botalón de cola

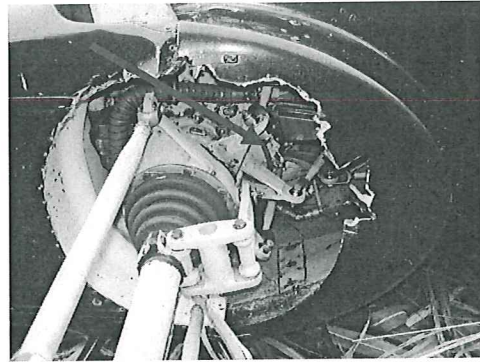
Fotografía No. 10

Vista de los daños de la transmisión

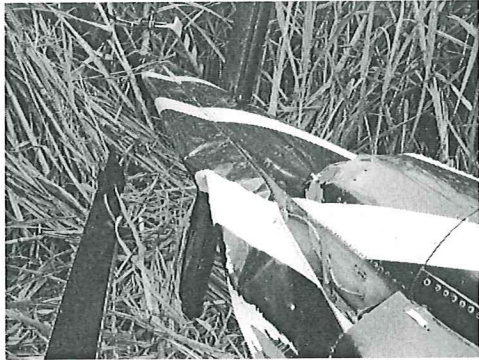
Fotografía No. 13
Vista del botalón de cola

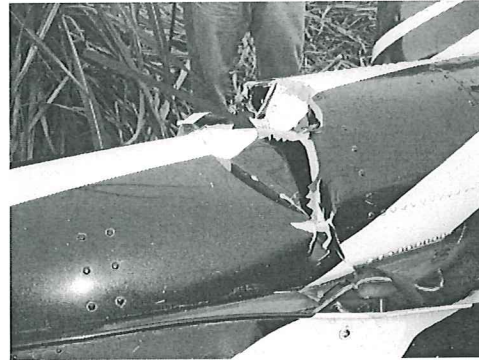
Fotografía No. 14
vista del dobles del botalón

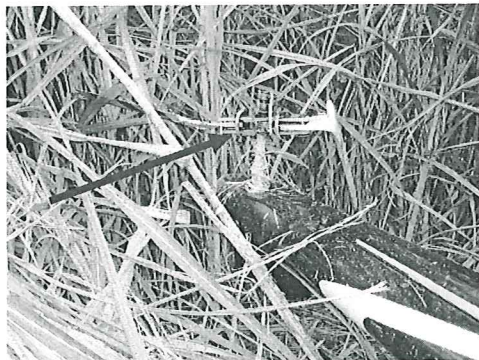
Fotografía No. 15
Vista del rotor de cola

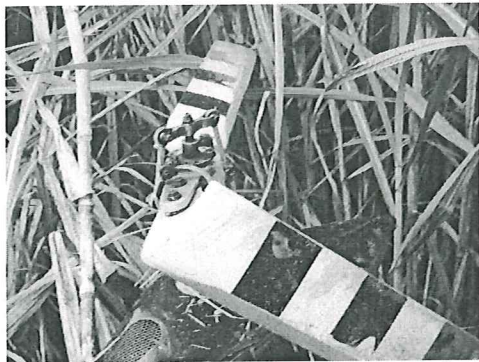
Fotografía No. 17

Las palas del rotor Principal y palas del rotor de Cola, se encontraron con daños totales por impacto a consecuencia del accidente.

Vista de las palas del rotor de cola

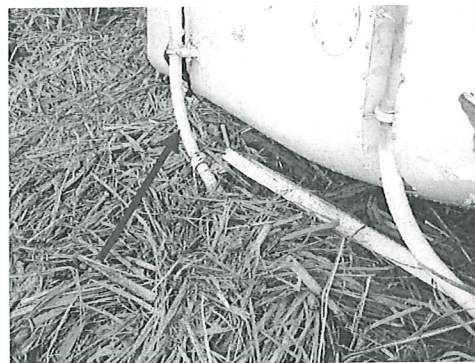
Fotografía No. 18

vista del los tubos cruzados del tren de aterrizaje

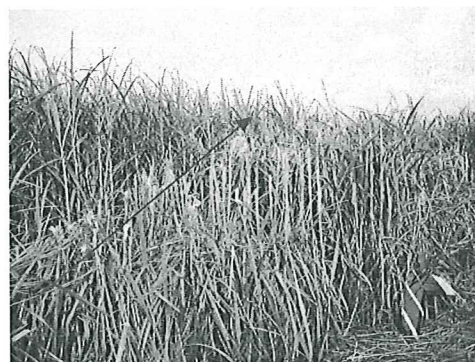
Fotografía No. 20

Cortes efectuados por las palas del rotor principal al efectuar la maniobra

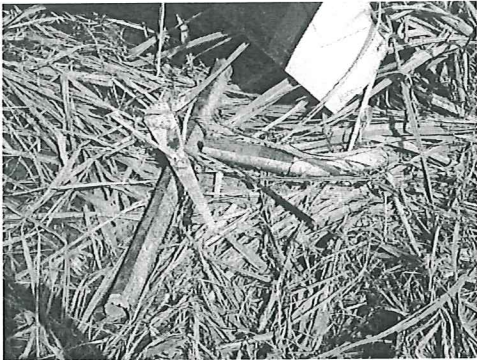
Fotografía No. 21

Vista de los restos del tren de aterrizaje

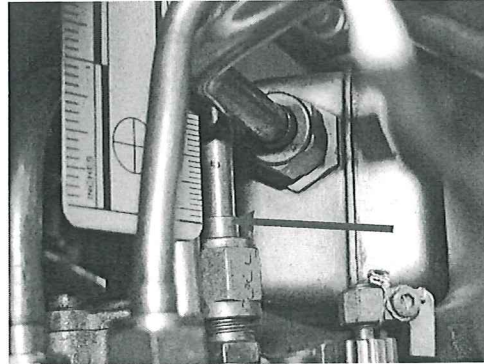
Fotografía No. 22

Vista del daño en la tubería del motor

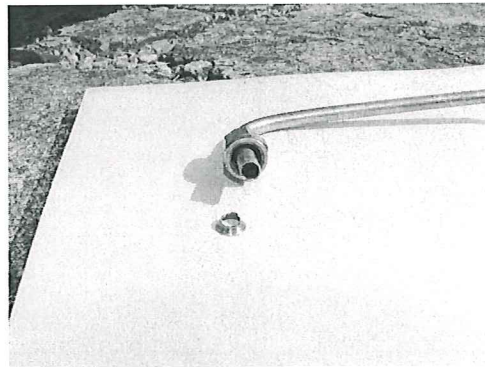
Fotografía No. 24
línea con fractura en una de sus bases

Se encontró una anomalía, la cual se considera como la posible causa de la pérdida de potencia del motor, lo que ocasionó el accidente, esta es una fractura de una línea de presión, específicamente la línea Pc, la cual provee aire presurizado proveniente del motor a la unidad de control de combustible (FCU), la fractura de la línea se encontró en la boquilla de 37 grados, que se acopla a la unidad de control de combustible.

La fractura de la línea de neumática sugiere que estuvo sometida a vibración de alta frecuencia, posiblemente pudo causar que presentara una fisura, que con el uso de la aeronave y el tiempo a largo plazo se convirtiera en una fractura en la base de la tubería con la unidad de control de combustible, provocando una fuga de aire presurizado del sistema neumático de combustible.

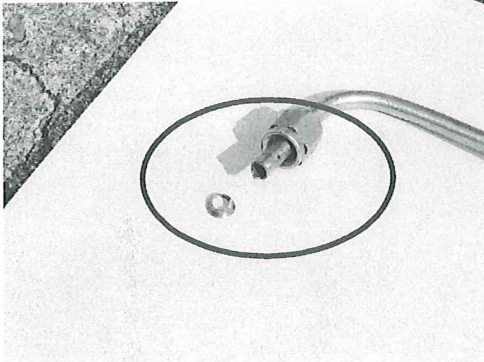
Fotografía No. 25
Vista del extremo fracturado

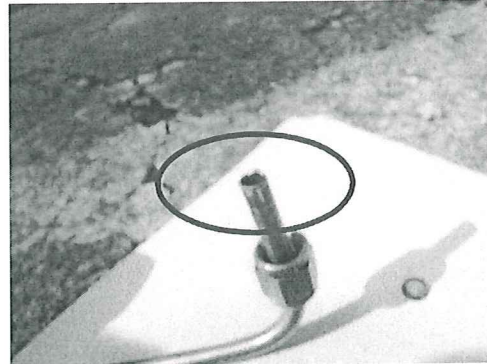
Fotografía No. 26
vista de la tubería fracturada

La tubería fracturada de la unidad de control de combustible de la línea Pc neumática presurizada, se considera como la causa probable de la pérdida de potencia del motor, la cual al hacerse sentir como una disminución de la potencia del motor y sobre los mandos del helicóptero como una reducción de RPM, esta reducción de RPM obligó al piloto al mando a efectuar una auto rotación inmediatamente por emergencia, continuando posteriormente con el accidente sobre el terreno.

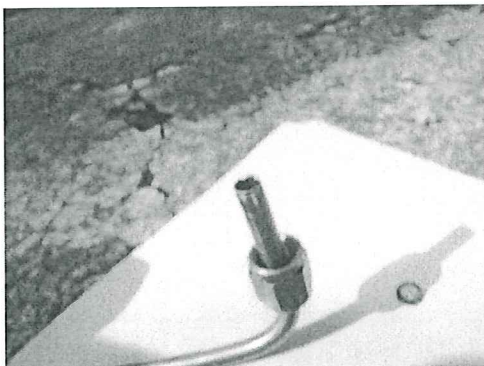
Fotografía No. 27
Vista de la fractura

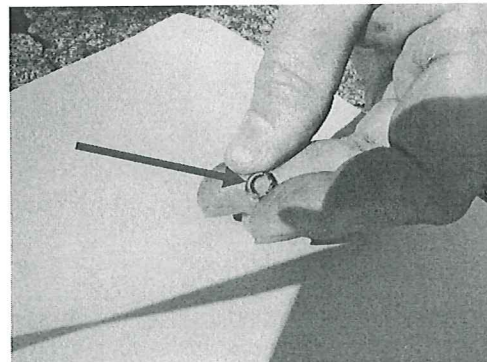
Fotografía No. 28
extremo de la tubería fracturada

Una vez rota la línea de presión, aproximadamente a 2 mm de la unidad de control de combustible, ocasionó la fuga de aire, la unidad de control de combustible al estar presurizada, el motor entrega las RPM normales a través de la unidad de control de combustible, al existir fuga de aire presurizado causa una reducción de potencia significativa en el motor.

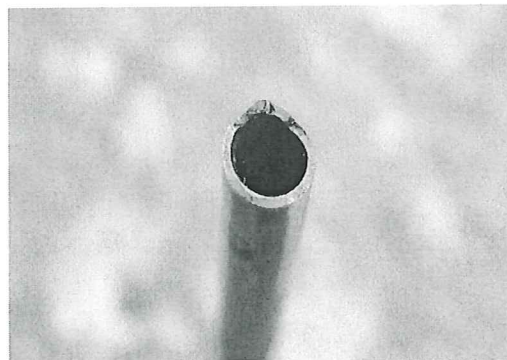
Fotografía No. 30
vista del área de la fractura de la tubería

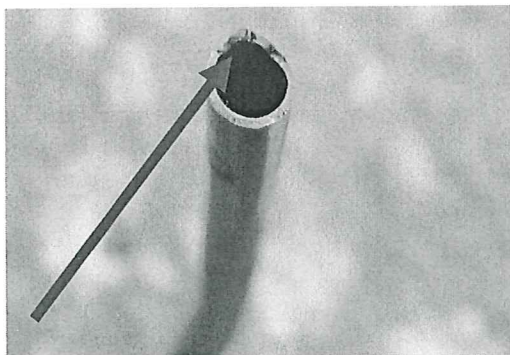
Fotografía No. 31
Área del inicio de la fisura

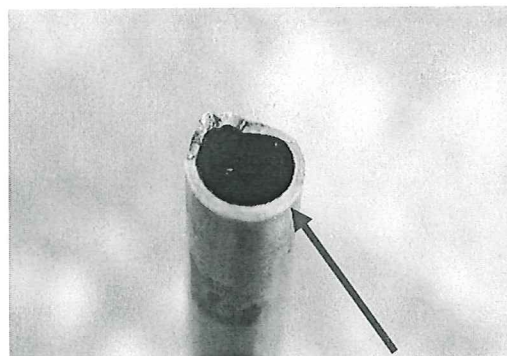
Fotografía No. 32
área de la fractura

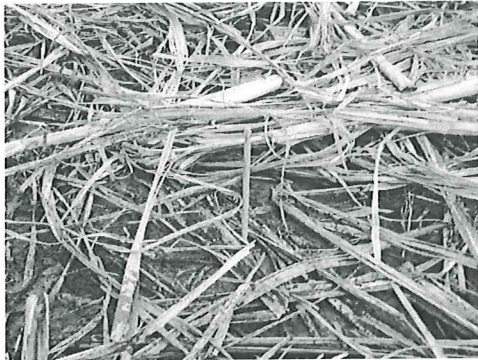
Fotografía No. 33
Área saturada de combustible

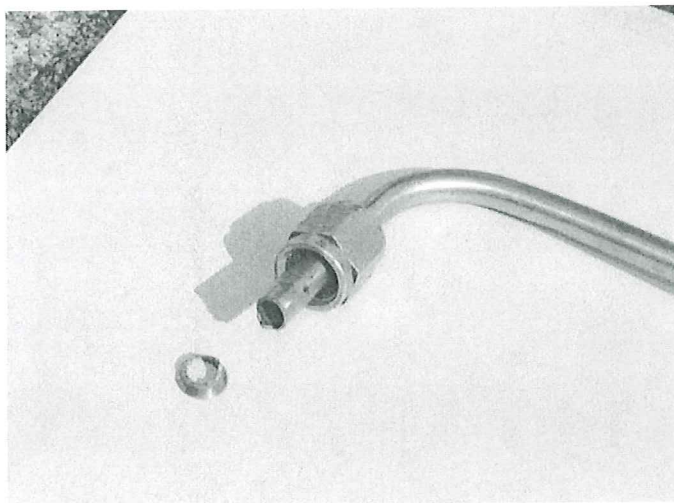
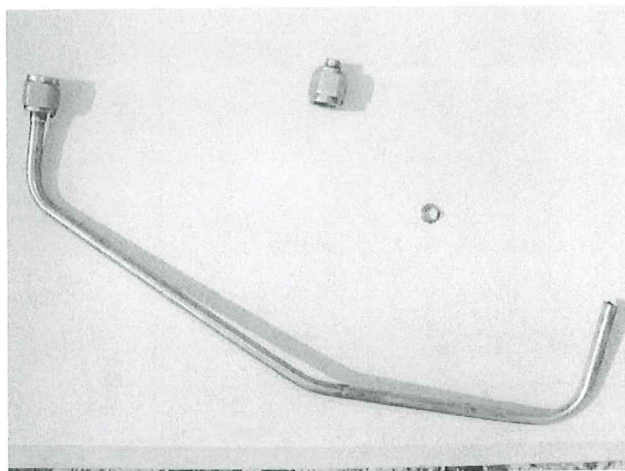
Summary: The only engine anomaly observed which was considered possibly contributory to the event was a fractured pneumatic control line. Specifically, the Pc air line, which supplies pressurized air to the engine Fuel Control Unit, was fractured at the Fuel Control Unit end where the straight line transitions to a 37° flare. Once the flared portion fractured, the air line sprung ~2mm away from the Fuel Control Unit fitting, allowing an air leak. Since this pressurized air is used to control the engine RPM and power level, an air leak in the Pc line can cause a reduction in engine power and RPM. The amount of power reduction and RPM loss will correlate to the amount of air leakage. However, the author was unable to determine the amount of air leakage on the accident engine.

Figures 1 and 2. Fractured Pc line

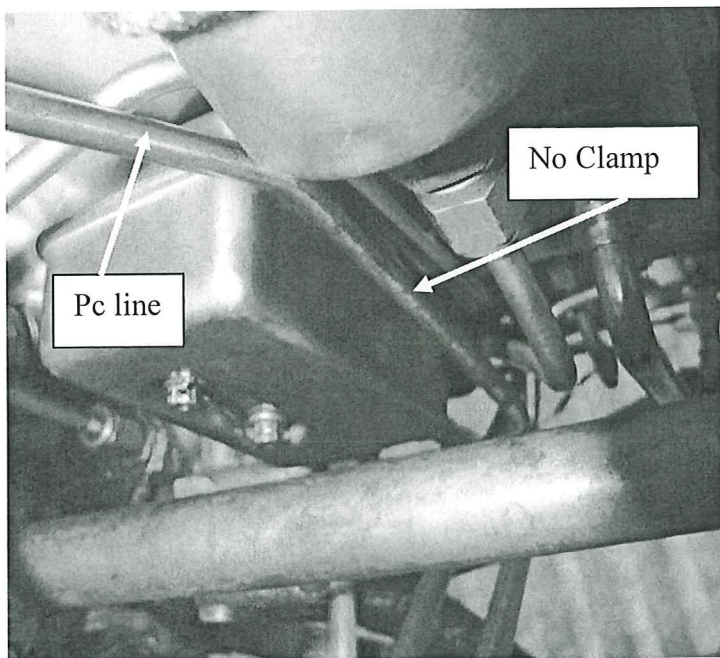
Figures 1 and 2 document the fractured line and figures 3 and 4 document the lack of proper clamping.

Figure 3. Pc line as installed (without proper clamp)
